TO: ALL AQUA-LUNG DISTRIBUTORS

## REGULATOR RECALL

SUBJECT: INSTALLATION INSTRUCTIONS FOR THE 1070-10  
CALYPSO HIGH PRESSURE SEAT AND BUSHING KIT

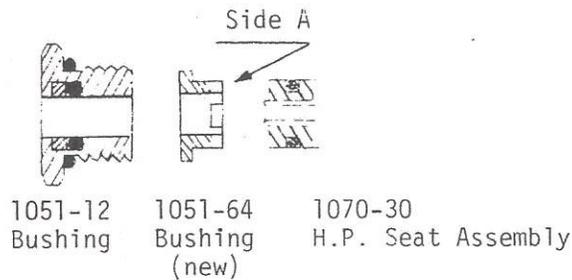
FIGURE 1

Insert the shaft through the new bushing and then place the new bushing with side A against the H.P. seat. See Figure No. 1 on next page. Care should be taken not to scratch the surface of the seat with the shaft.

15. Installation of the new bushing (P/N 1051-64) is then most easily accomplished by utilizing a suitable diameter wood or metal shaft. (The Allen screwdriver used to turn the adjustment nut is a suitable tool.)

16. If required, lubricate the O-ring on the bushing (P/N 1051-12) with silicone grease before reinstalling the bushing into the regulator.
17. Lubricate the piston O-ring as necessary.
18. Install the main spring and piston, being careful not to nick or scratch the piston tip.
19. Clean any foreign material from the threads on the main body and cap before reassembly. Insure that the two adjustment springs are in the cap before reassembly.
20. After reassembly is complete, once again install the intermediate pressure gauge into the port fitting and pressurize the regulator. Depress the second stage purge button several times. Allow the regulator to remain pressurized at 2200 psi minimum for 30 seconds. Depress and release the purge button while observing the I.P. lockup.
