Corrosion of Steel and Aluminum Scuba Tanks

Francis C. Cichy
Hilbert Schenck
John J. McAniff

University of Rhode Island Marine Technical Report 62

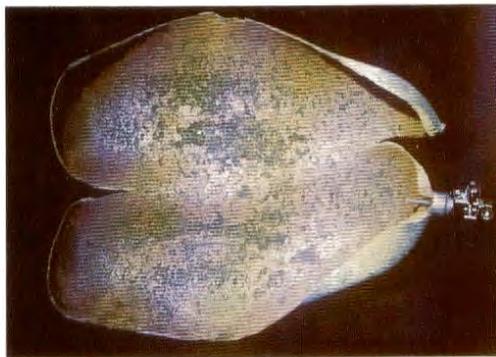
Figure 1. Scuba tank that exploded while being charged at the M. & E. Marine Supply Co. A roughly circular area at the tank center let go, and the crack propagated toward the base and the valve end. This can be clearly seen by the slanted tears in the metal edge. The tank shows general corrosion, with much greater thinning at the point where the crack began. A handful of rust was in the tank.

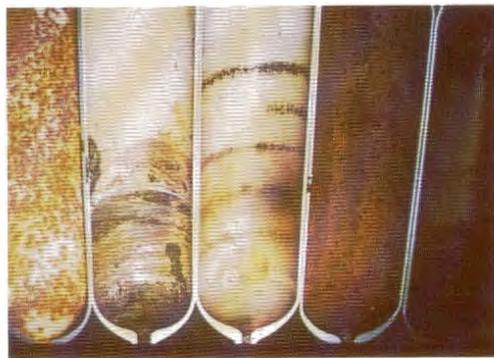
Figure 2. Sectioned halves of five condemned-in-service steel cylinders.

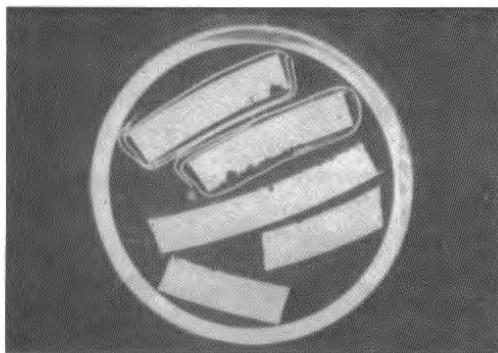
Figure 3. Various wall sections from a tank manufactured in 1961. Some of these pits extend one-third of the way into the wall.

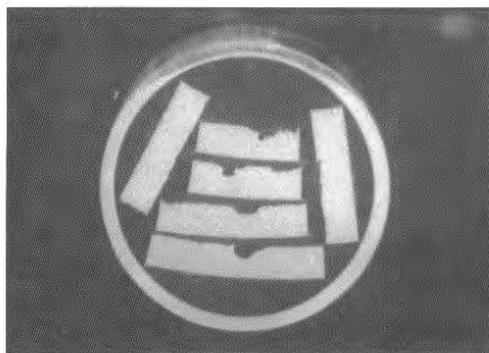
The wall sections in Figure 4 show the worst case of pitting in the 40 cylinders. This was an unevenly coated cylinder made in 1963, with corrosion damage heavy in the lower half. The detected thinning here was almost one-half the wall thickness, but deeper pits could have been present. Out of the eight sectioned cylinders, four had "large amounts" of rust, enough to plug or stop an air regulator if the diver maneuvered so as to bring the particles down over the regulator valve inlet extender.

Figure 4. Various wall sections from a tank manufactured in 1963 that was unevenly coated. These were the deepest and most serious pits found in the condemned-in-service cylinders.

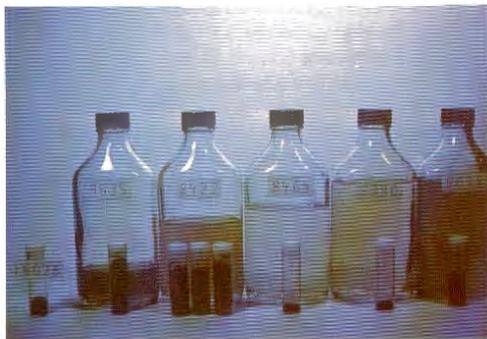
Figure 5. Water and filtered products from, left to right, Tanks 16026, 9535, 8422, 8464, 8390, and 8019. Almost no free water remained in 16026.

At the end of the 100-day test, the cylinders were bled remotely, from outside the bunker, and the tanks carefully emptied. Figure 5 shows the result of pouring out what fluid remained in each tank and filtering this residue. Tank 16026 was so heavily corroded, Figure 6, that no free water remained, the water being entirely retained in the spongy corrosion product. Tank 9535, though given the identical treatment, showed both less corrosion and less water retention in the product.

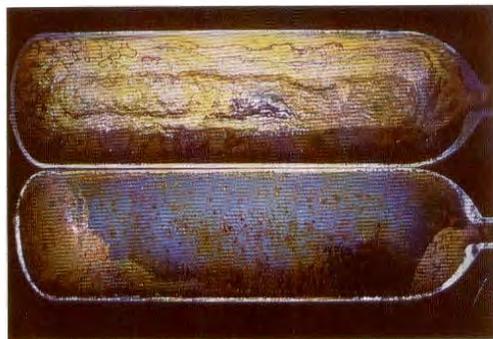
Figure 6. View of Tank 16026. Drastic corrosion damage occurred under seawater layer (upper half).

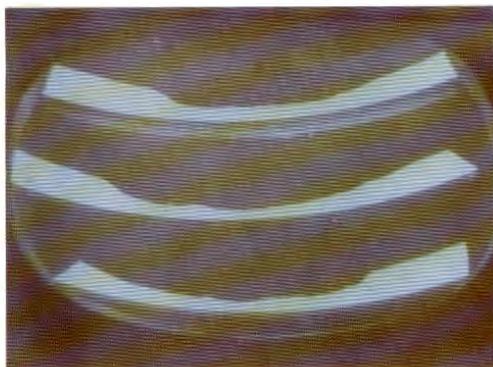
Figure 7. Wall sections from Tank 16026. The heavy product shown in Figure 6 was cleaned away, and this drastic wall thinning was discovered underneath it; up to two-thirds of the wall is gone. These deep craters are over one inch across and run the entire length of the cylinder.

As Table 2 shows, the horizontal cylinders with full pressure and salt water had by far the most dangerous corrosion. Figure 7, which shows wall thinning of two-thirds of the wall thickness, suggests that Tank 16026 could not have lasted much longer without an explosion. Yet Tank 9535, a replicate of 16026 as far as treatment is concerned, showed only about half the thinning and, as Figure 5 shows, less water absorption. The only explanation for these differences appears to lie either in the mild initial corrosion seen inside the tanks before the test or in the two tanks being somehow different as to steel lot, manufacturing methods, or something we did not detect.

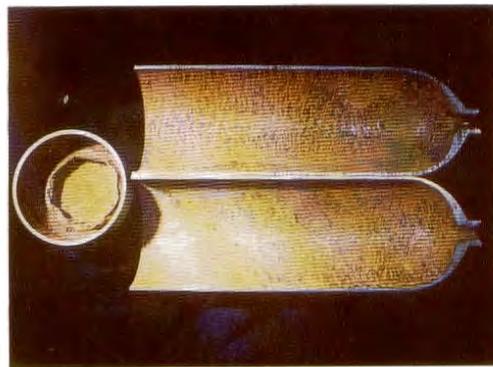
Figure 8. General view of Tank 8422. Corrosion is light except in bottom, where an extensive corrosion ring appeared.

Because water surface area obviously has a large effect in the rate at which this attack proceeds, Tank 8422, Figure 8, showed less wall thinning, although a complete and complex corrosion ring formed at the water surface to steel interface. The section, Figure 9, shows how the ring grows by depleting the parent metal beneath.

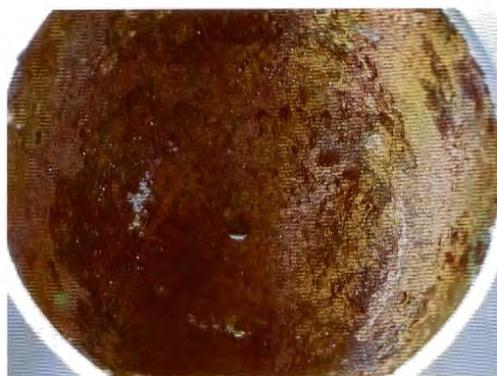
The state of steel cylinder 46343 readily confirmed the work of Lieutenant Peyser in 1970. Its minimum remaining wall percentage of 46.4 percent (see Table 5) was between the values for cylinders 9535 and 16026 in Table 2. A corrosion ring had completely covered the neck region, Figure 11, leaving only a hole through which the valve extender protruded. The entire interior was heavily attacked with large sheets of corrosion scale hanging on the walls. Based on the loss of oxygen, a production of about 1.5 pounds of rust was predicted—a quite reasonable estimate of the amount actually seen. Since this cylinder underwent much heavier attack than the vertical cylinder 8422 in Tables 1 and 2 (compare Figures 8 and 11), it is reasonable to suppose that the brass valve extender may have aided corrosive attack in the water-covered neck region (although these are not compara-

Figure 11. Close-up of the neck section of test cylinder 46343. Note the large corrosion ring. The hole in its center was caused by the plastic valve extender which protruded through the water-gas interface.

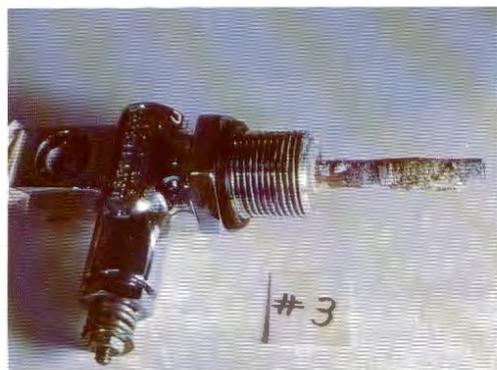
Figure 12. Valve of test cylinder 31365. Note the accumulation of corrosion products on the brass extender and within the threads.

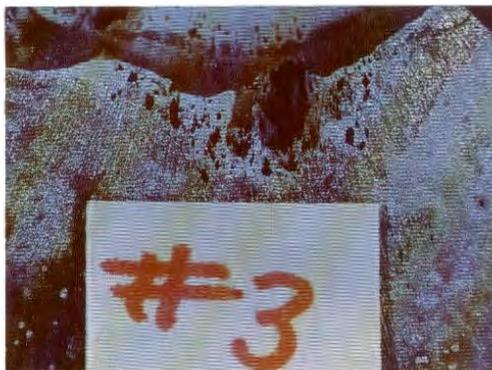
Another accelerating effect in 31365 was the direct corrosion of the brass extender and the resulting continual introduction of copper ions into solution. The combination of anionic species contained within the salt water, such as chloride and bicarbonate ions (present as NaCl and NaHCO_3), dissolved oxygen, and copper ions, will have a synergistic effect, thus increasing the overall rate of attack (Becerra and Darby, 1974; Porter and Hadden, 1954; and Davies, 1959). Corrosion of the actual brass was verified by running X-ray fluorescent patterns on the corrosion products removed from the brass extender (see Figure 12). The results showed these products contained substantial quantities of both copper and zinc. In addition, copper depositions were found throughout the entire wetted surface area of 31365 as brown or reddish-brown stains, indicating areas where the copper had actually plated out on the aluminum (Figure 13).

Figure 13. Immediate neck section of test cylinder 31365. The deepest pit within this cylinder is shown in the center of the photograph with many "satellite pits" surrounding it. Copper depositions, the reddish-brown stains, can readily be seen on the aluminum surface, especially near the pit formations.

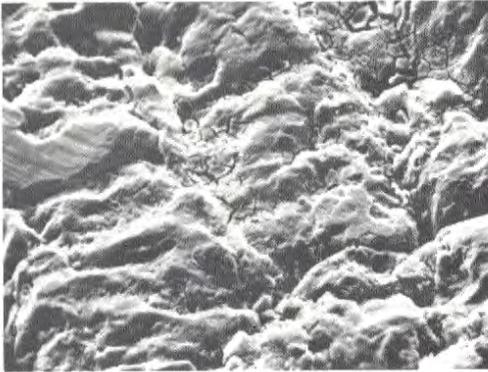
Figure 14. A sample of the flaws in the anodized oxide film, taken with a scanning electron microscope at 500X. Similar flaws were observed in all samples, generally taken from the immediate neck sections.

All seven aluminum cylinders in the Table 4 test had an interior anodized coating produced by the cylinder manufacturer using a proprietary method. Figure 14 shows the character of this coating at 500X magnification. It averaged about one-thousandth of an inch in thickness, but cracks, some of which pierce the film, can be seen. Figure 15, showing one of the larger pits in Tank 31365, at 50X, suggests that damage starts where major flaws in the film, shown at the top and right of the photo, may initiate pitting. When the bottom of the Figure 15 pit was examined under

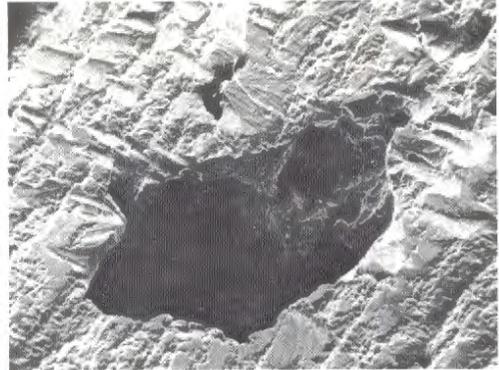
Figure 15. Overall view of pit in Tank 31365, using a scanning electron microscope at 50X. Note the initiation of pits at major flaws in the oxide film.

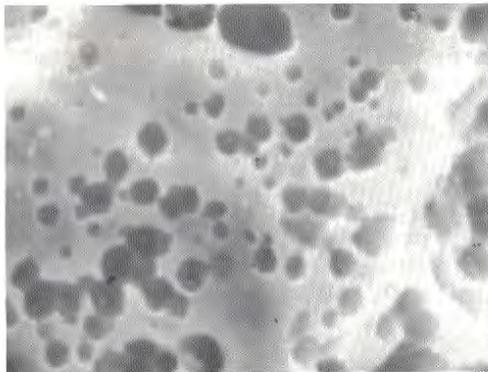
Figure 16. Characteristic bottom structure of the aluminum pits, taken with a scanning electron microscope at 5000X. The many small pits present at the very bottom of the pit appear to initiate and guide further growth. This pattern of attack was observed in all aluminum pits studied with the SEM, regardless of their location.

the high magnification of 5000X, tiny new pits, already joining to form crevices, could be seen (Figure 16), and this condition was found in all the pits so studied in cylinders 31365 and 31622.

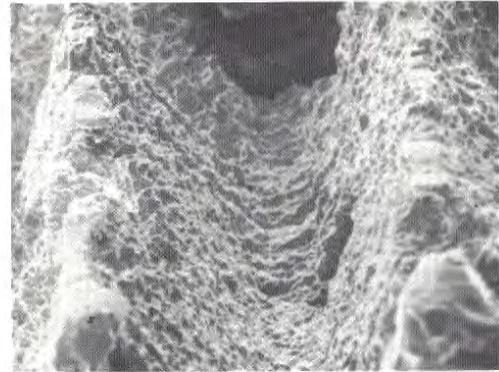
Figure 17. Exposed threads in Tank 31365 (scanning electron microscope at 50X). Since the exposed threads were virtually adjacent to the brass valve, which had an easily accessible supply of oxygen, the extensive corrosive damage can be attributed to galvanic corrosion.

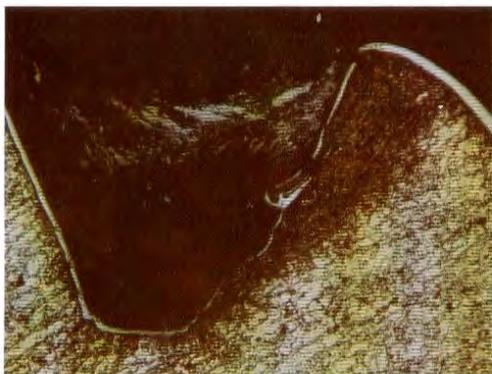
When the brass valves of Tanks 31173 and 31374 were sectioned and etched, obvious dezincification could be seen in their threads. Tank 31173's valve showed this in its most pronounced form (Figure 18, dark area), where the top of the lowest engaged thread is sectioned. The distortion of this thread by removal attempts is also apparent, as well as its broken chrome plating.

Figure 18. Dezincification of valve in Tank 31173 (light microscope at 100X). Shown is the top of the last thread which has been etched in order to show the characteristic microstructure associated with two-phase brass (40% Zn, 60% Cu). The reddish-brown areas mark the locations where dezincification took place. The silver-colored outline is the chrome coating. Also note the small pieces of chrome, brass, and aluminum which apparently broke off under the applied torque.

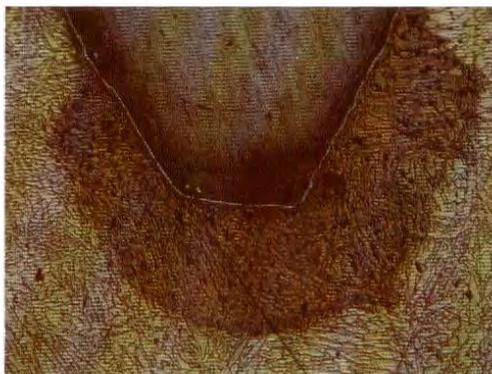
Figure 19. Dezincification of valve in Tank 31173 (light microscope at 100X). This is the bottom of the second thread, which has been etched to show microstructure. A fair amount of dezincification has taken place. In the center of the picture can be seen aluminum that was literally "deposited." Also note the deformation of the thread and the cracks in the chrome coating caused by the applied torque.
