Death of a recreational diver after a fall on board **MV JEAN ELAINE** 15nm NW of Cape Wrath 14 August 2012

Marine Accident Investigation Branch
December 2013

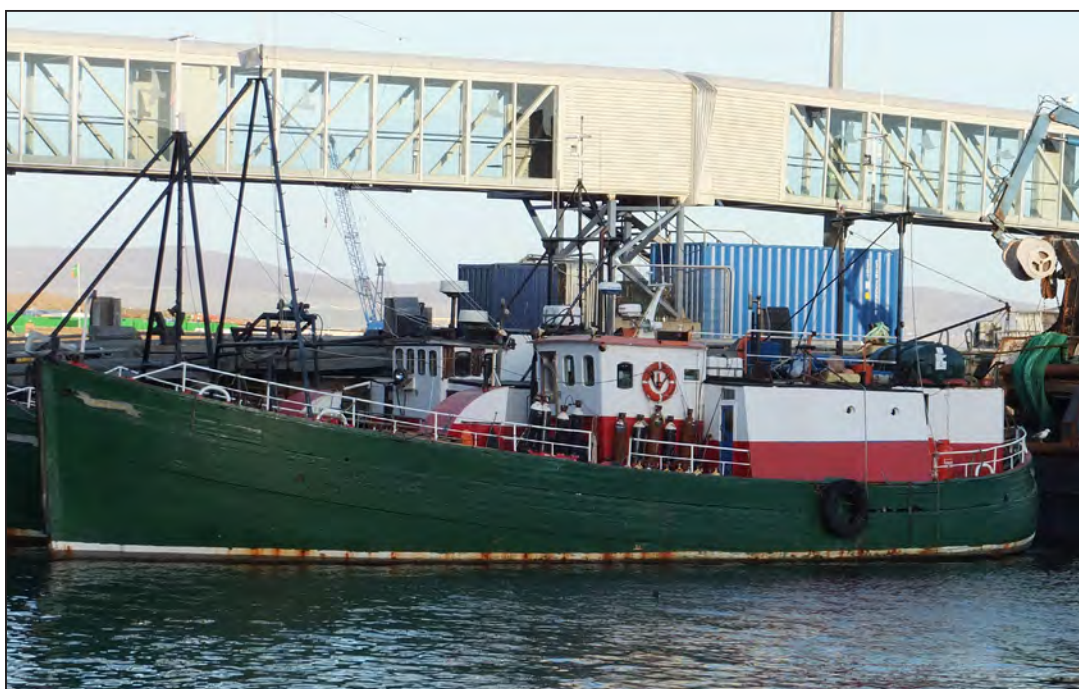
Figure 1: *Jean Elaine*

At 1607 (UTC+1) on 14 August 2012, Mr Lex Warner, an experienced recreational diver, fell onto the deck of the dive workboat *Jean Elaine* (**Figure 1**). When he fell, Lex was fully dressed and prepared for diving to a depth of 95m; he was wearing heavy equipment on his back and had additional diving gear attached to his front and sides. Although it was not immediately apparent, it was likely that the diving gear impacted into Lex's abdomen during the fall and caused significant internal injuries. Having been helped back to his feet by the boat's crew, Lex made a positive indication that he wished to continue with the dive and he entered the water unaided. At a depth of 88m, Lex started an unplanned return to the surface. He lost control of his breathing and buoyancy shortly afterwards. Three of his fellow divers attempted to increase his buoyancy and administer breathing gases; however, Lex did not start breathing again. He was attached to a lifting bag and ascended to the surface from a depth of 65m. Despite further medical treatment on board *Jean Elaine* and by the emergency services, he could not be revived and was pronounced dead later that evening.

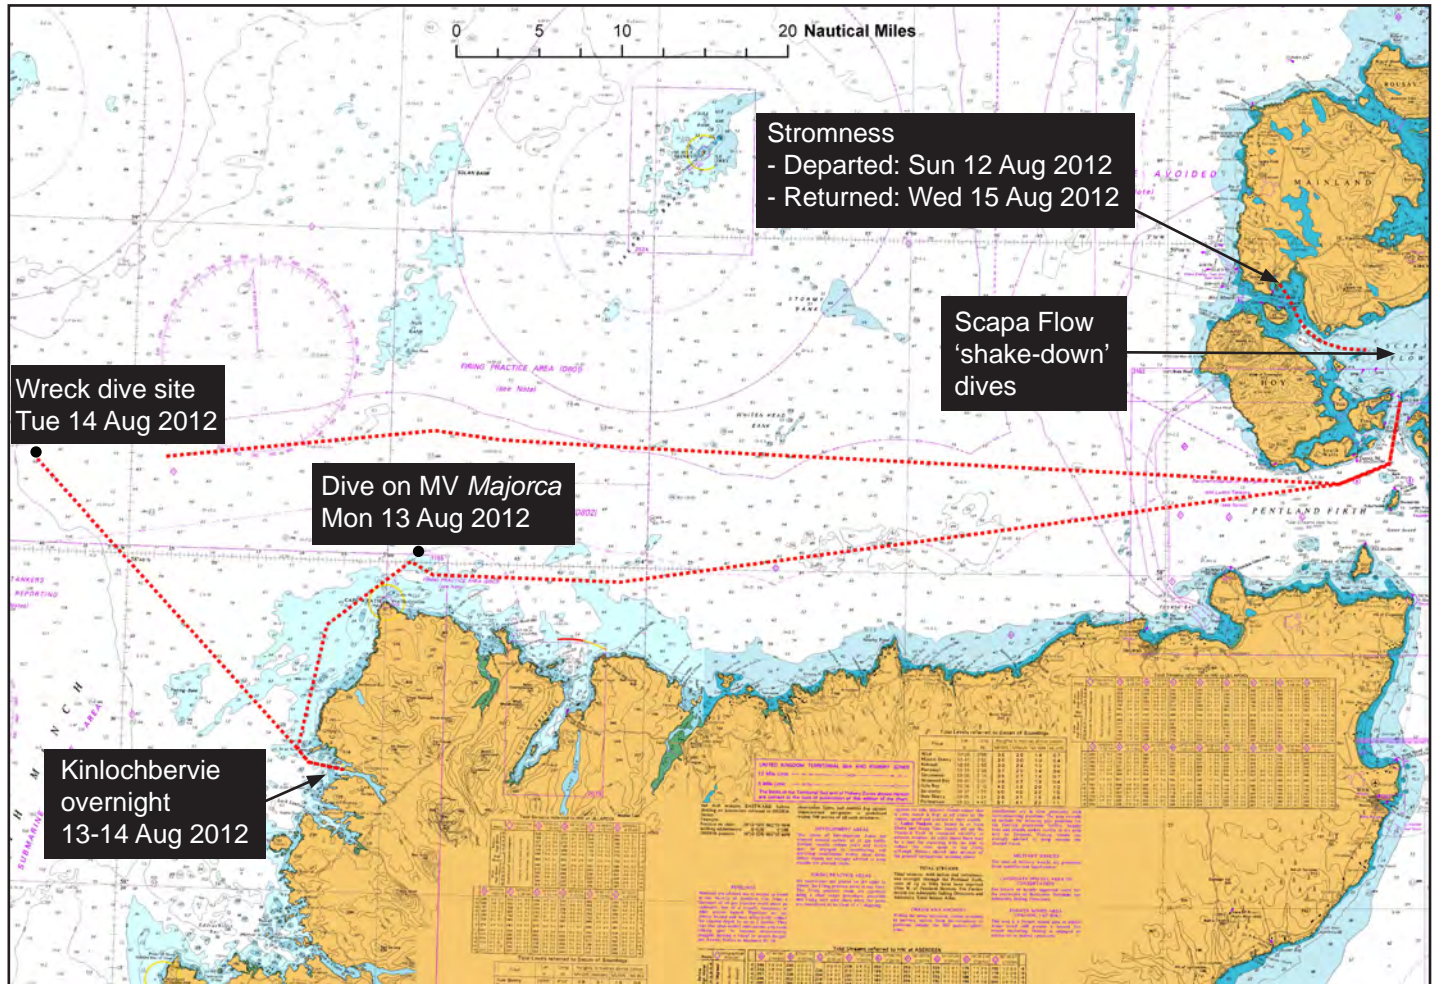
Figure 2: Voyage of *MV Jean Elaine*

However, in the course of the morning the weather started to improve, so a revised plan was agreed between the skipper and the divers to find and then dive on an unnamed wreck which was thought to be approximately 15 miles north-west of Cape Wrath (**Figure 2**). At 1130, *Jean Elaine* departed Kinlochbervie and headed towards the wreck. During the passage, the weather conditions continued to improve and other divers described Lex as being excited, but also nervous, in anticipation of the first deep dive of the trip on a previously unexplored wreck.

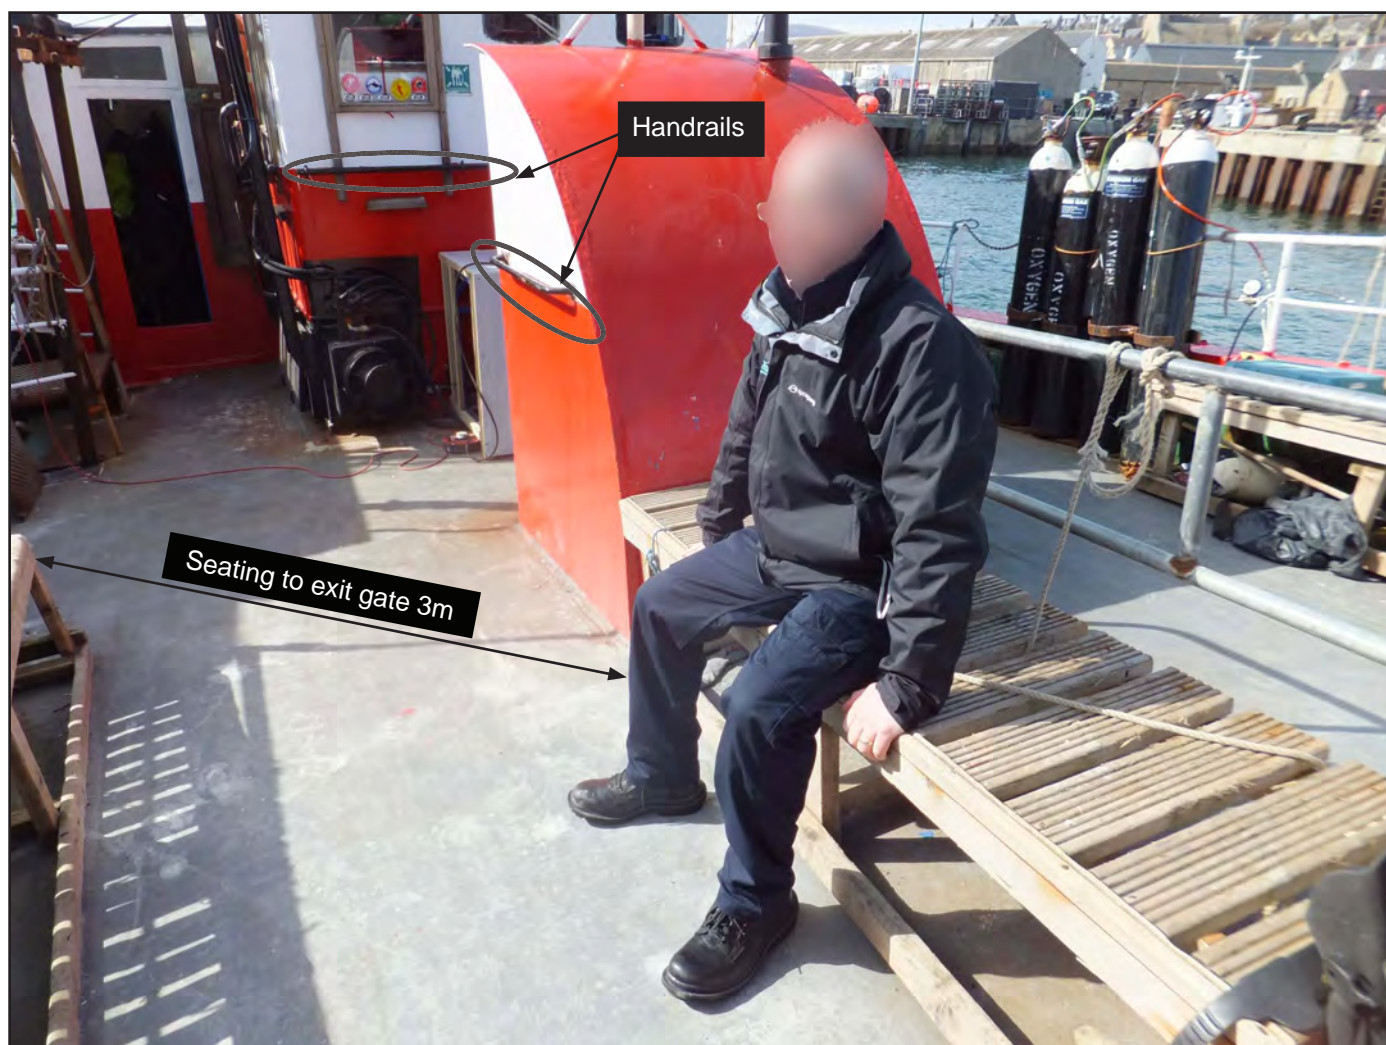
Figure 3: Lex's dressing position

The weather conditions had further improved and were now considered to be very satisfactory for diving; it was warm and sunny with a slight swell. Lex sat on the central bench on *Jean Elaine's* foredeck, facing to starboard (**Figure 3**) to prepare for the dive; this included a successful pre-dive check of his rebreather equipment. All the divers prepared their equipment in isolation; they did not check or assess each other's kit.

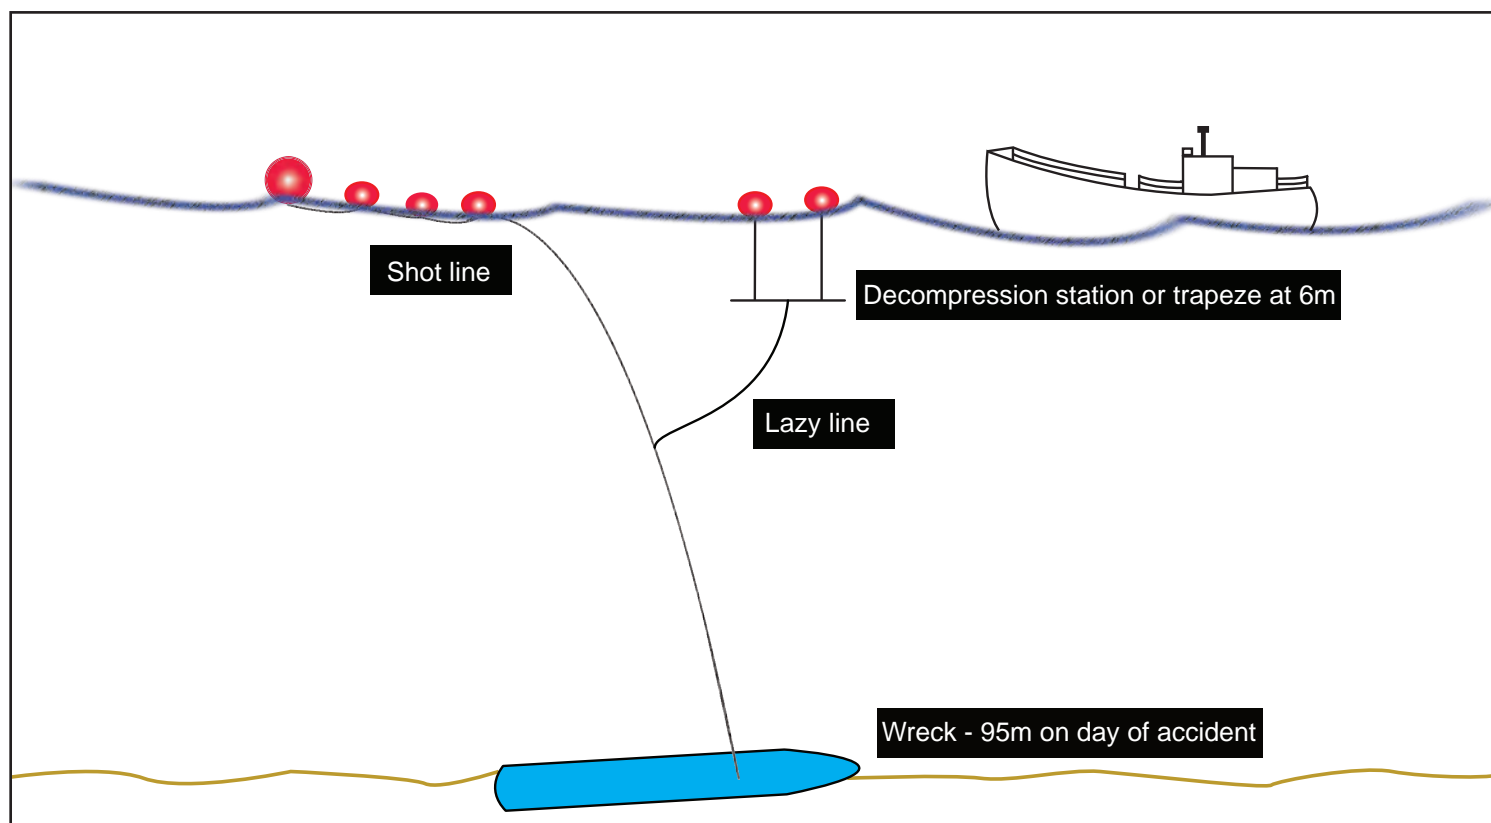
Figure 4: Diving rig

At 1558, in suitable tidal conditions and with all personal preparations complete, the skipper gave a signal for divers A and B to enter the water. They did so and then swam down the shot line to connect its lower end to the wreck. They were soon followed into the water by divers C and D who set up the 'lazy' shot line³ and trapeze decompression station at a depth of 6m (**Figure 4**).

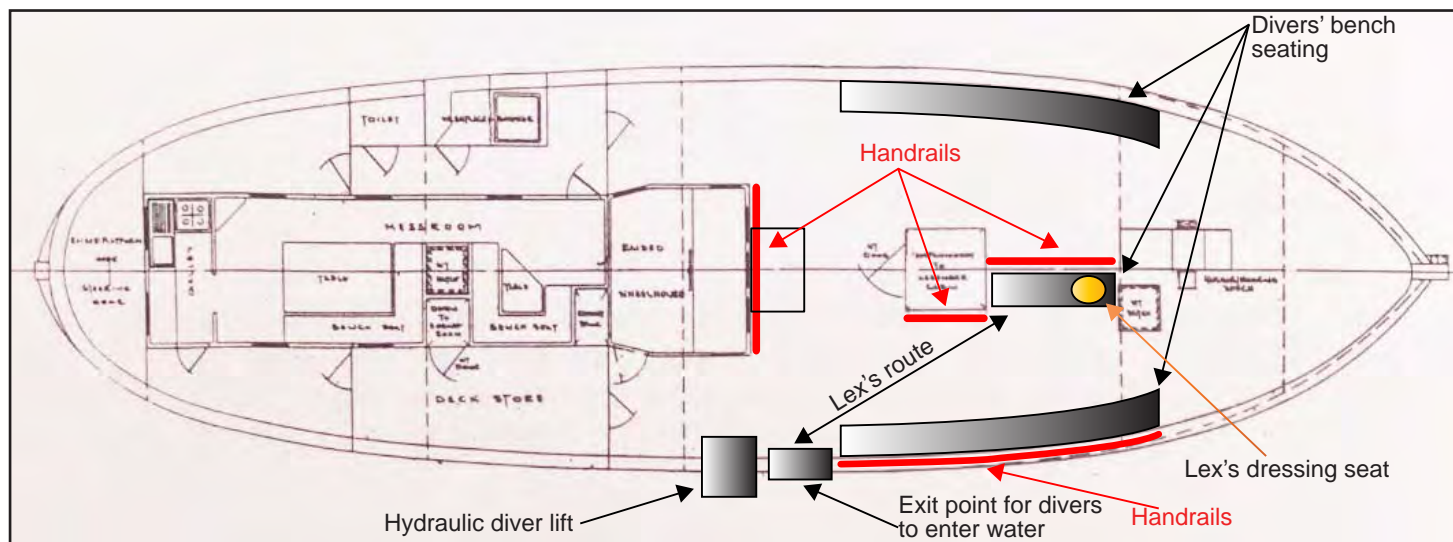
Figure 5: Deck layout

At 1607, diver E entered the water and, at the same time, Lex stood up from the bench and started to walk towards the exit gate on *Jean Elaine's* starboard side (**Figure 5**). Lex was fully prepared for the dive carrying his rebreather equipment on his back, three bail-out bottles⁴ on his sides and additional personal diving kit including a torch, surface marker buoys and dive computers. Lex was breathing through his rebreather and wearing his facemask, gloves and fins.

Built in 1956 as a trawler, since 1994 *Jean Elaine* had operated from Stromness as a commercially operated diving workboat supporting recreational and research diving. At the time of the accident, the vessel was coded as a workboat under the Maritime and Coastguard Agency's (MCA) Marine Guidance Notice 280 *'Code of Practice for Small Vessels in Commercial use for Sport or Pleasure, Workboats or Pilot Boats'* (MGN 280). *Jean Elaine* was certified to carry up to 12 passengers with a total loading not to exceed 2050kg (including a maximum of 1000kg of equipment). The vessel's permitted area of operation was Category 2 (up to 60nm from a safe haven). The vessel was fitted with handrails behind the central bench seating, along the sides of the foredeck accommodation access housing and across the front of the wheelhouse (**Figure 5**). The wooden deck was covered with a non-slip coating.

Lex Warner fell, either as a result of losing his balance or tripping, as he tried to walk unaided from the central bench seating on *Jean Elaine's* foredeck to the exit gate on the boat's starboard side. When he fell, Lex was walking forwards, wearing diving fins. This would have created a very significant tripping hazard. He was also carrying his heavy diving equipment, which raised his centre of gravity and reduced his stability. His visual situational awareness, which could have aided his balance, would almost certainly have been degraded as he was also wearing his diving facemask.

The handrails on *Jean Elaine's* foredeck provided good support in the areas where divers prepared their kit, on either side of the accommodation hatch area and across the front of the wheelhouse. However, there was no physical support immediately available to divers if they crossed in a straight line from the central dressing bench directly to the exit gate.

- 2013/245** Conduct a thorough review of the safety arrangements on this and any other vessels he may operate, to ensure that:
- The risks involved in supporting recreational diving operations are formally and methodically assessed.
 - The employment of crew and positioning of physical supports are considered in order to minimise the risks to divers as they prepare to enter the water.
