# INCIDENT NEWSFLASH

from External Source – for your information  
Ref: ES/2006/02

## “Gas Bottle Explosion”

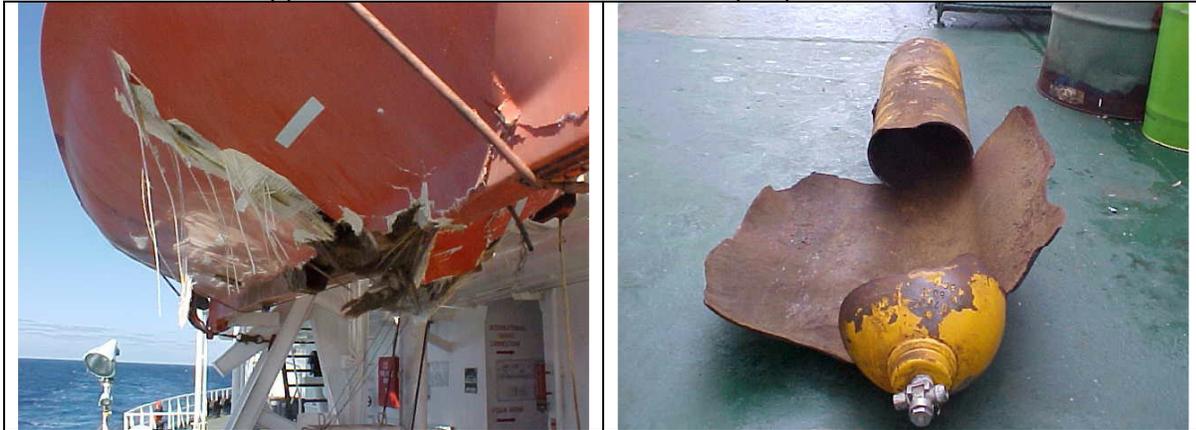
A gas bottle exploded in a lifeboat of a vessel during the process of charging it up from the Breathing Apparatus Air Compressor.

The Master of the 8 years-old vessel was in proximity of the lifeboat and he was very seriously wounded. The bottle was quite old with different numbers/dates.

The photographs below speak for themselves. Unfortunately one person was injured – imagined the results if this happened on the deck area with more people around.

- (1) The incident related to Life Saving Equipment, which indicated the lack of inspections and maintenance programs.
  - (2) Ensure air cylinders or gas bottles are all in good condition. EU guidelines are:  
Visual inspections every 2 years and pass hydro-test requirements every 5 years
  - (3) Cylinder(s) in poor condition should not be moved or depressurized and should be roped off and warning sign(s) clearly displayed
-
