MK20 Yoke / DIN Dealer Service Alert July 2007

RE: MK20 Yoke/DIN Service Inspection Procedure Notice

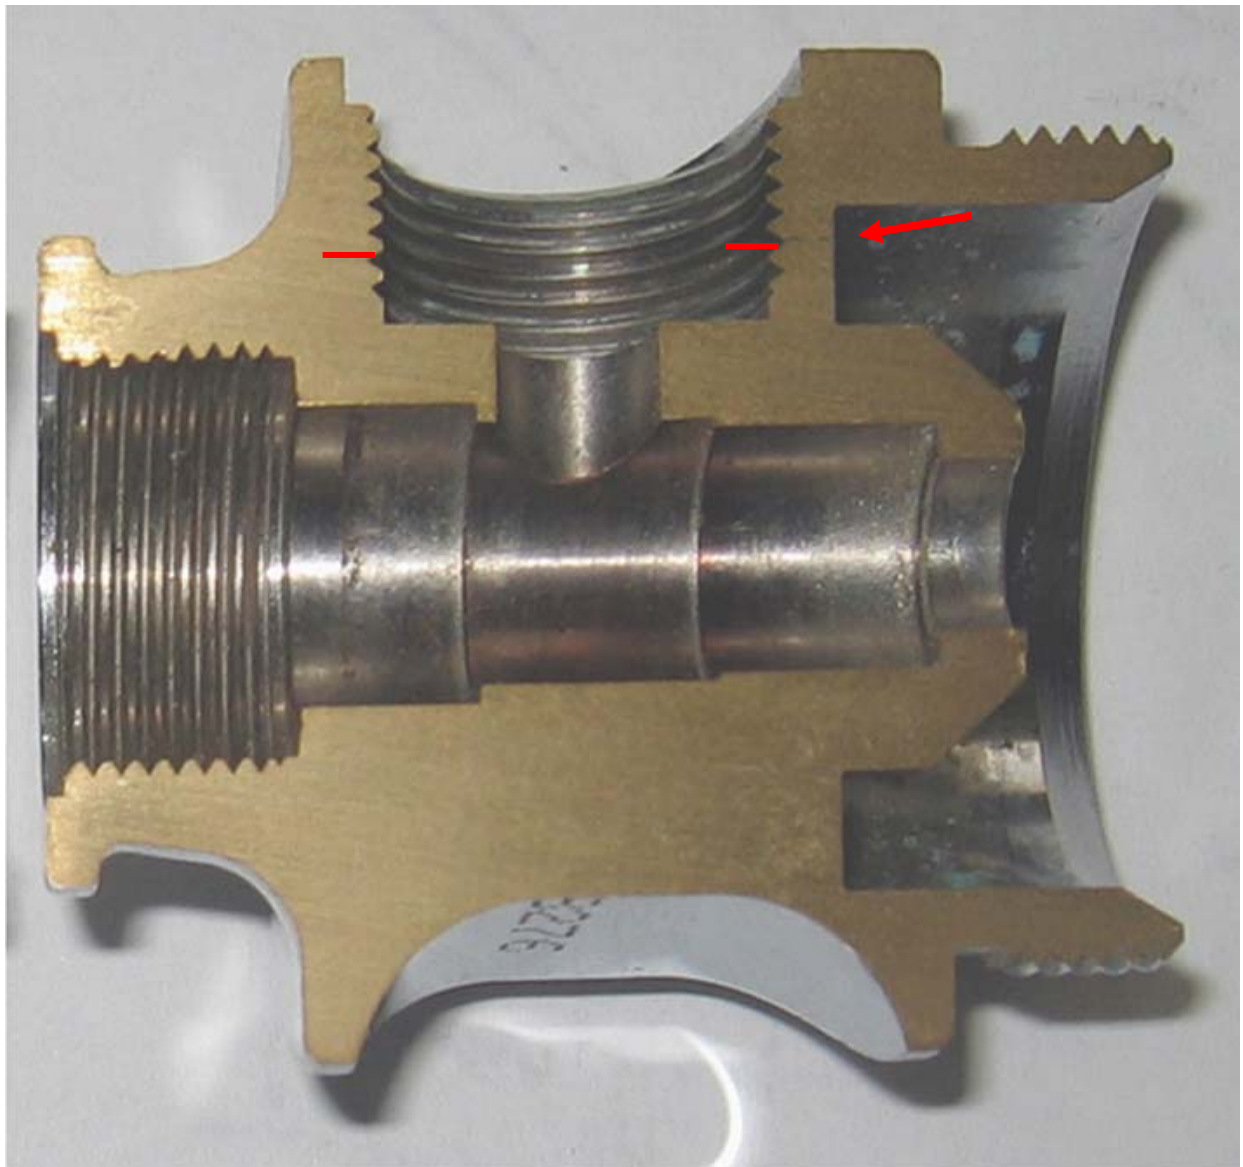
In 2005, Dealers were instructed to replace un-shouldered yoke nuts in all MK 20 regulators with shouldered yoke nuts. The shouldered yoke nut eliminated the possibility of stress crack formation resulting from over-torque of the un-shouldered yoke during servicing. Dealers were also asked to visually inspect MK20 regulators prior to installing new shouldered yoke nuts for any pre-existing cracks which might have the potential to continue to grow slowly over time even after the shouldered yoke nut is in place.

Figure 1. Cross-section of an MK20 body showing a growing crack (red lines) from the root of the threads. This crack will be visible at the location indicated (red arrow) before the crack ruptures. This location is invisible to the user during use; however it will be apparent to the service technician while the regulator is disassembled.

1. Fully disassemble the regulator.
2. Viewed in the cross-section, look for a pre-existing crack that begins at the base and grows into the threads at the location indicated on Figure 1.
3. Viewed on the low-pressure side of the regulator body, there is little material and a pre-existing crack will be visible at the location indicated in Figure 2. Pre-existing cracks are visible at the surface in this location to the service technician, but are likely not visible to the consumer.

IMPORTANT: PLEASE INCLUDE THIS INSPECTION AS PART OF YOUR ROUTINE SERVICE OF MK20 REGULATORS, AND RETURN ANY CRACKED PART TO SCUBAPRO FOR PROMPT REPLACEMENT.

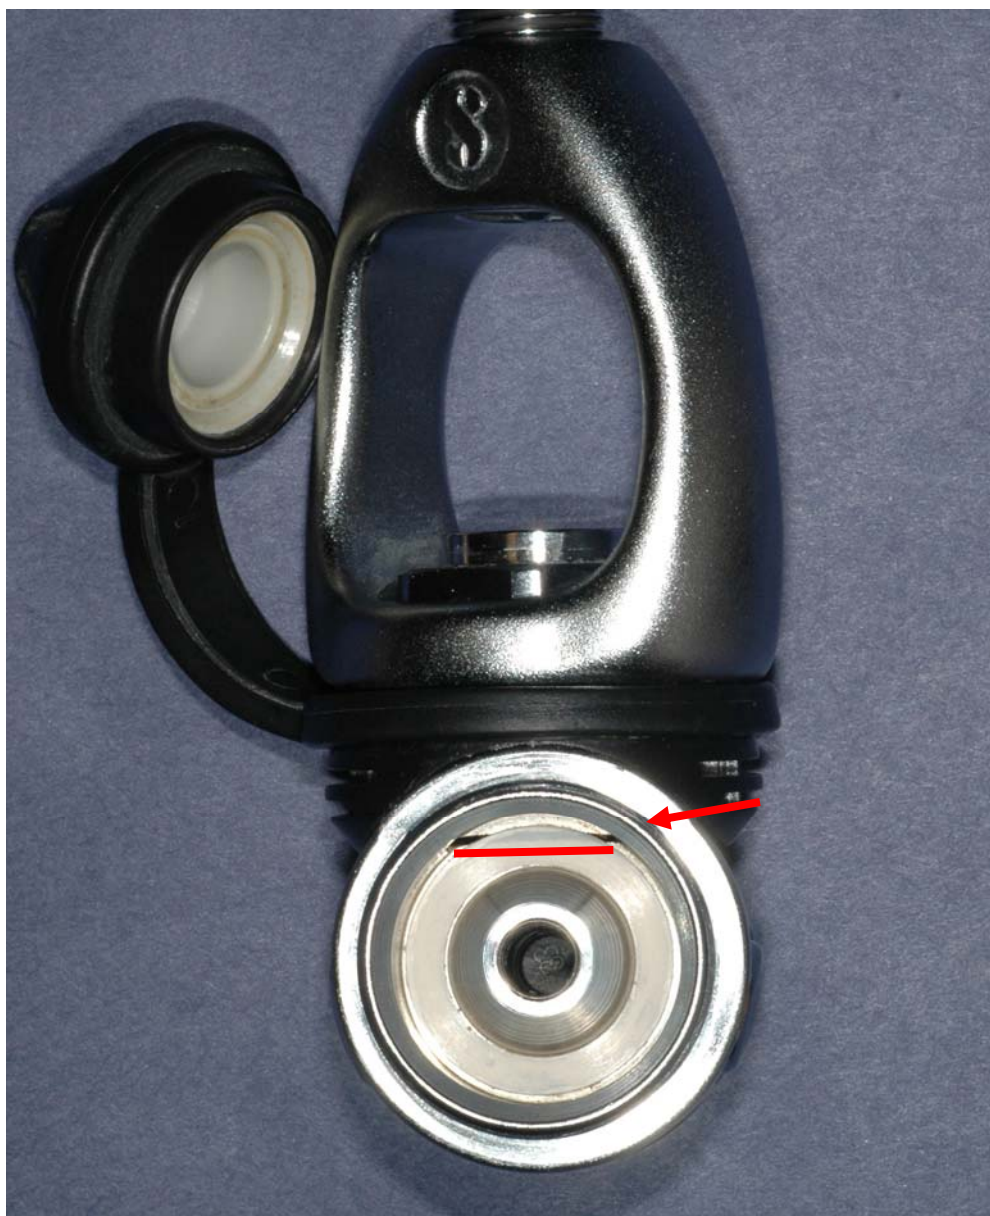
Figure 2. Detail of the view a service professional will have of the low-pressure side of the regulator body. If a pre-existing crack exists, it will be visible at the location of the red line in the photo. Service Technicians should add the inspection of this area (red line and arrow) during all MK20 service procedures and return any cracked components to SCUBAPRO for replacement.
