Aqua Lung America

TECHNICAL BULLETIN

May 29, 2017
No. 47

SUBJECT: Potential Loosening Of The ACD Yoke System

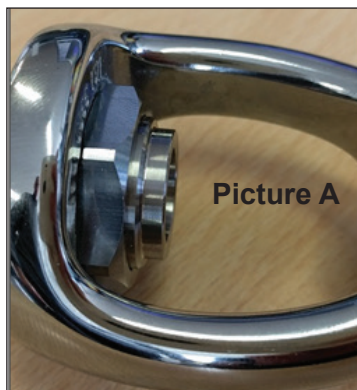
INSPECTION: If the Shutter Valve is loose you may see a gap between the Shutter Crown (2) and the Yoke Retainer (3). Picture (A) shows the correct position and picture (B) shows a loosened Shutter Valve (1) with a gap. If there is a gap, you will need to follow the corrective action.

CORRECTIVE ACTION: If you find a gap in the Shutter Crown then you will need to remove the Yoke Retainer (3) from the regulator body and re-torque the Shutter Valve (1) to 27 in-lbs (3 Nm) following the instructions in the maintenance manual.

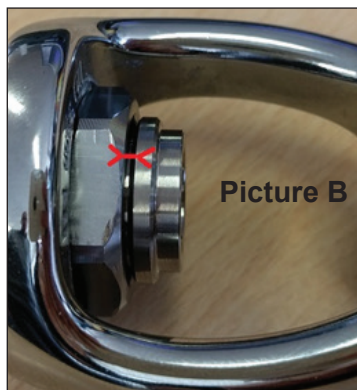
In ACD yoke systems where the Shutter Valve (1) has not been properly tightened to the recommended torque, there is a possibility that the Shutter Valve may loosen itself from the Yoke Retainer (3). This can happen while trying to remove the first stage from the cylinder while the first stage is still under pressure or while partially pressurized (always make sure the regulator is completely de-pressurized before trying to remove the first stage from a cylinder).
