Corrosion of Steel and Aluminum Scuba Tanks

Francis C. Cichy
Hilbert Schenck
John J. McAniff

University of Rhode Island Marine Technical Report 62

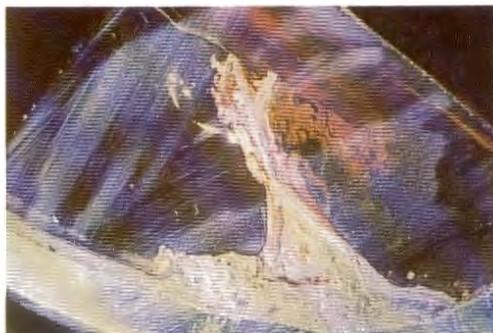
Because water surface area obviously has a large effect in the rate at which this attack proceeds, Tank 8422, Figure 8, showed less wall thinning, although a complete and complex corrosion ring formed at the water surface to steel interface. The section, Figure 9, shows how the ring grows by depleting the parent metal beneath.

Figure 9. Close-up (1½ inches wide) of cross-section of corrosion ring in Tank 8422. Note that the ring grows by depleting the parent wall metal beneath it.

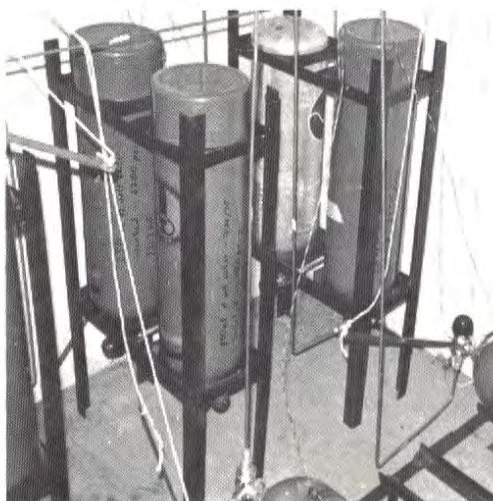
Figure 10. Setup of vertical test cylinders 30943, 31173, 31365, and 46343 in ammunition bunker.
